Appendix B

Photos

Part I – Truss Spans

Part II – Kittery Approach Spans

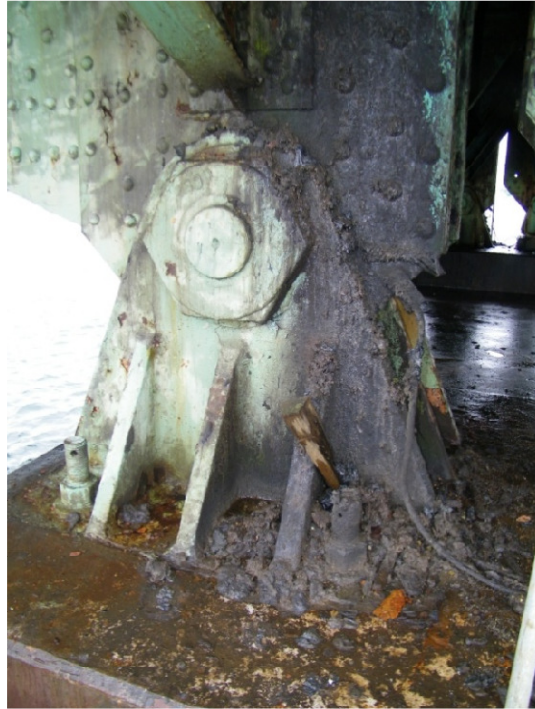
Photo 1.49: Span 3, Southwest Bearing. Tar-like debris around bearing and inside of bearing assembly.

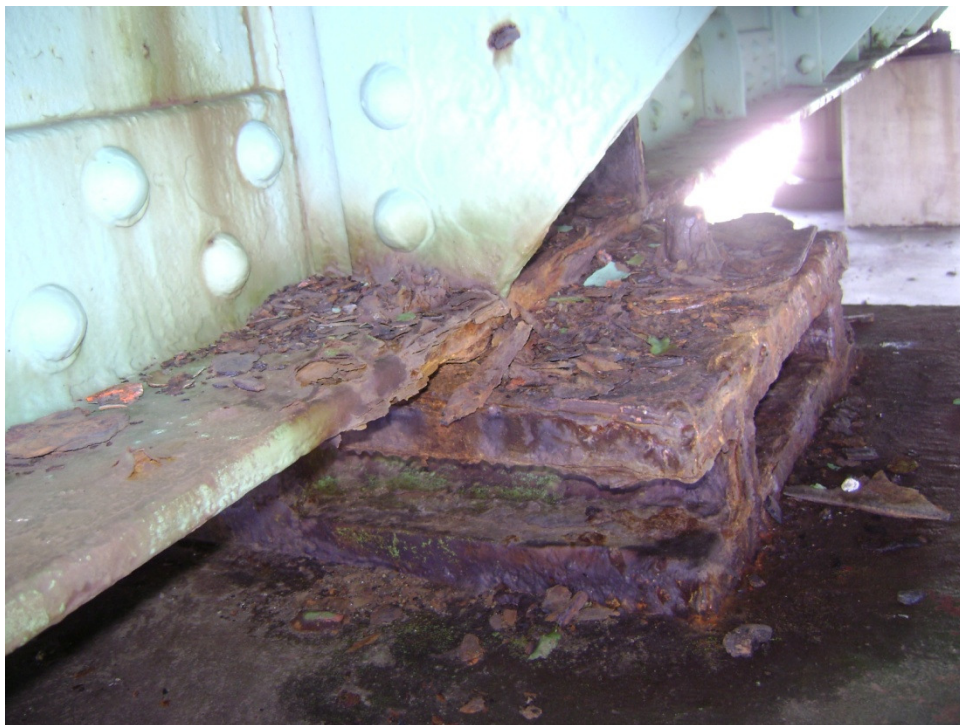
Photo 2.4: Kittery Approach, FB0, East Bearing.

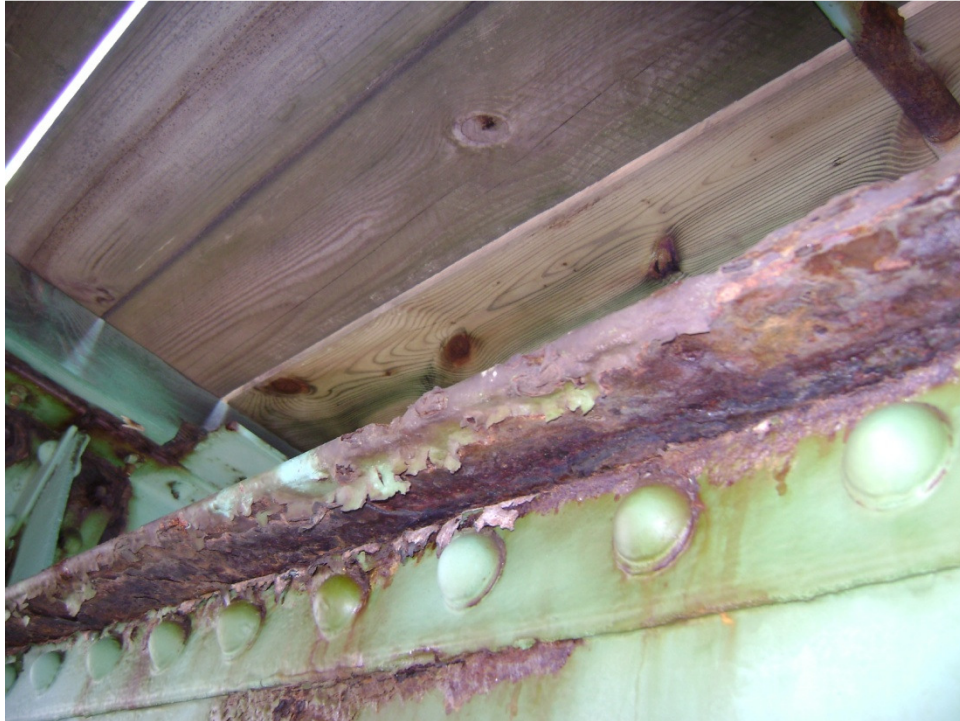
Photo 2.9: Kittery Approach, FB2. Top flange of SW3.

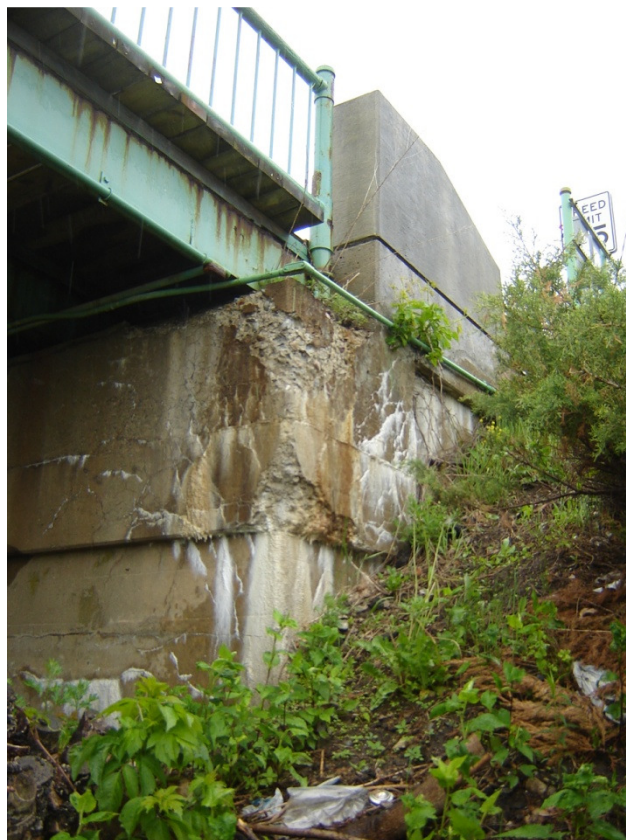
Photo 2.18: Kittery Approach Span. East corner of Maine Abutment.
